Wear performance and wear monitoring of nylon gears made using conventional and additive manufacturing techniques

School of Mechanical & Manufacturing Engineering, UNSW Sydney, Australia

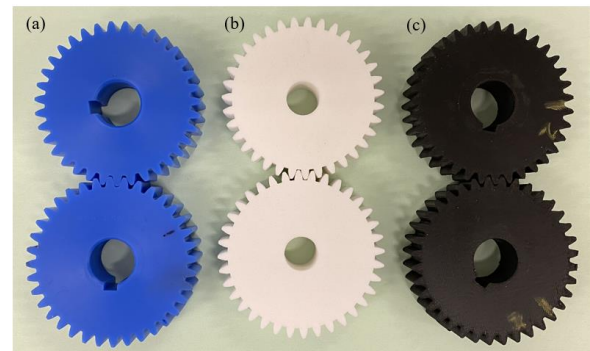
Fig. 1. Three pairs of new nylon gears: (a) MC nylon gears made using injection moulding, (b) PA12 nylon gears manufactured using the SLS method, and (c) carbon fibre reinforced nylon gears manufactured using the FDM method.

Among the three pairs of nylon gears (Figure 1), one pair made of MC nylon was manufactured using injection moulding method and was purchased from KHK Gears. One pair of PA12 nylon gears were made using SLS and by PCBWay, and the third pair of nylon gears was made using Bambu carbon fibre reinforced high temperature nylon and the FDM method. Some main material properties of these gear materials can be found in Table 1.

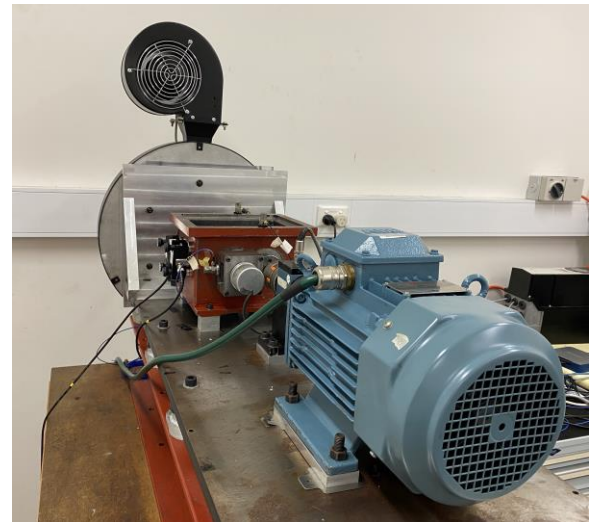
**Fig. 2.** The spur gearbox rig.

A spur gearbox rig located in the School of Mechanical & Manufacturing Engineering, UNSW Sydney, was used to conduct gear tests. This rig, shown in Figure 2, has the following four main components: a spur gearbox, a 4 kW 3-phase induction motor connected to the input shaft, a magnetic particle brake to apply load to the output shaft and a variable frequency drive to control the speed of the input shaft. Detailed information on the rig can be found in [15]. Multiple sensors were installed on the rig. They include three accelerators installed on the gearbox casing to collect vibration data in the x, y and z direction.

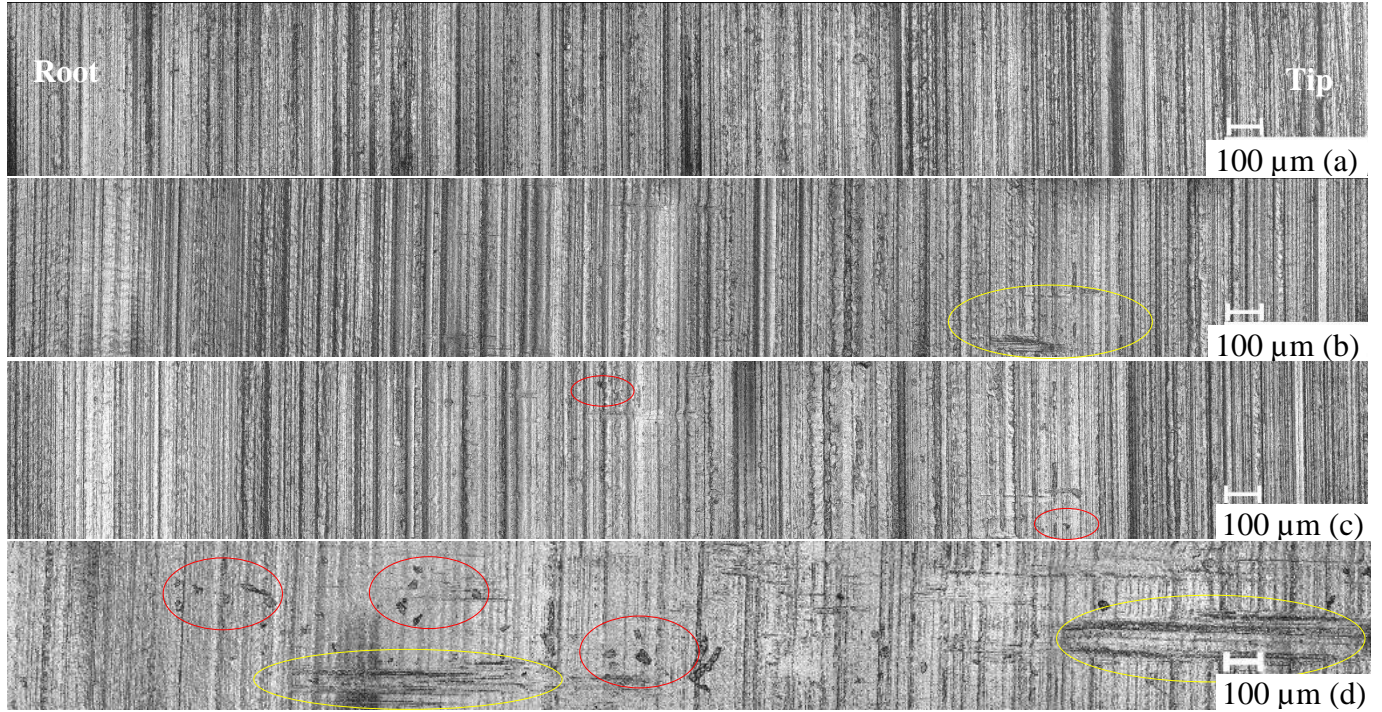
Fig. 3. Images of the commercial nylon driving gear at different running cycles: (a) 0 cycles, (b) 4.8×10^3 cycles, (c) 45.8×10^3 cycles, (d) 193×10^3 cycles. Examples of scratch marks caused by the sliding motion are highlighted in yellow, while pits on the tooth surface are highlighted in red. (Note: sliding due to meshing is in the horizontal direction.)

The microscopic surface of the injection-moulded nylon gear teeth initially appeared quite smooth, with manufacturing marks running along the tooth face width (Figure 3(a)). The first signs of abrasive wear appeared at 4.80×10^3 cycles in localised areas of the driving gear (see an example in the yellow highlighted area in Figure 3(b)). The scratch marks, which follow the sliding direction of the two gear surfaces when in mesh, then expanded to other areas. Those scratch marks could be viewed with the naked eye (Figure 4). Surface pitting was observed at 45.8×10^3 cycles (see the red circled small pits in Figure 3(c)) and continued until the end of the test (Figure 3(d)). Similar wear marks were observed on the driven gear.

self-lubricated condition and when the applied load was 10 Nm or below. Once the torque was increased to 15 Nm at 129×10^3 cycles more surface pitting (Figure 3(d)), along with deep scratch marks and plastic

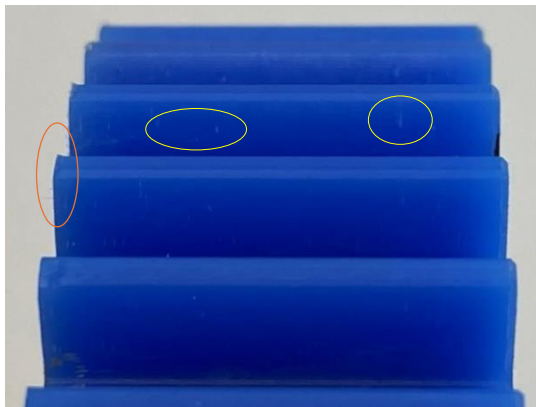
Fig. 4. Scratch marks (circled in yellow) on the driving gear and temperature related plastic deformation at the edge.

deformation at the end (Figure 4), were observed. This indicates that the critical torque of these injection-moulded nylon gears is around 10 Nm, as reported in [11]. The two wear mechanisms observed under the critical torque, namely, abrasive wear and surface pitting, are to be expected and were reported by other researchers [12].

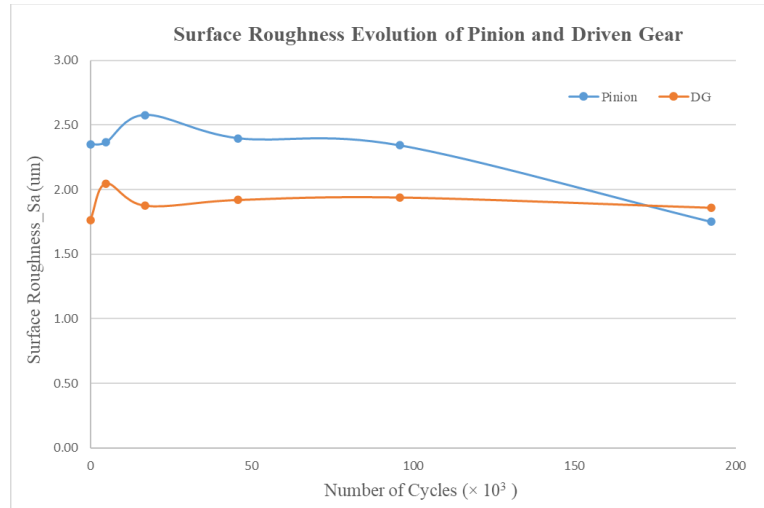
Fig. 5. The surface roughness (S_a) values vs running cycles of the driving (pinion) and driven gear (DG) made using the injection-moulding method.

The S_a values of the contact surfaces of both the driving and driven gears were measured and are presented in Figure 5.

The S_a data in Figure 5 show that the pinion's surface roughness decreased during the wear process, while the DG's surface roughness remained steady overall, likely due to the initial surface roughness of the pinion being

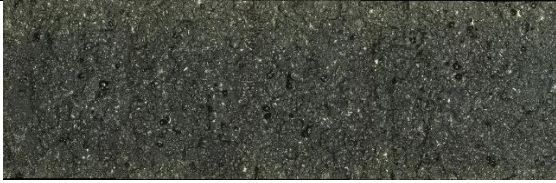
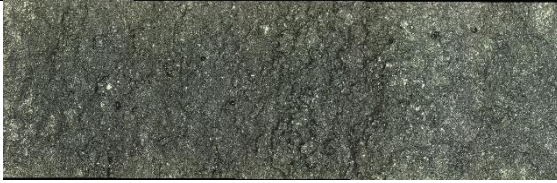
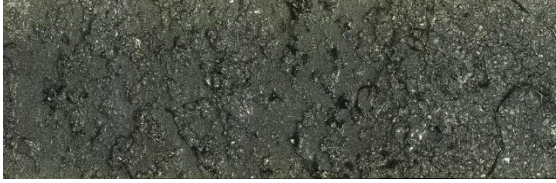
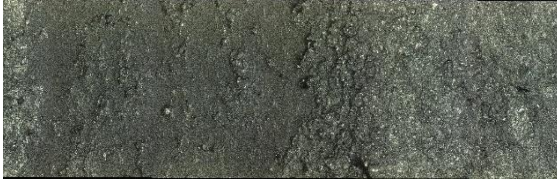
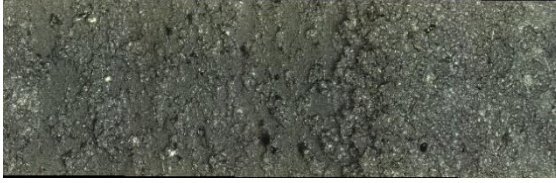
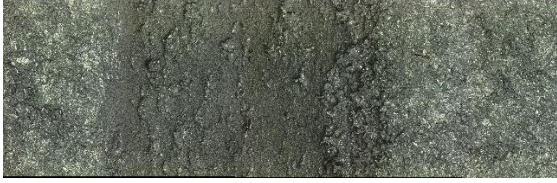
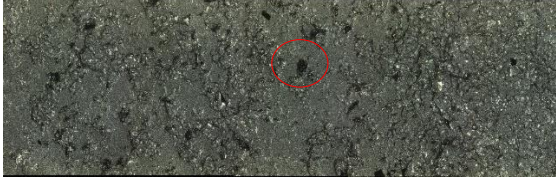
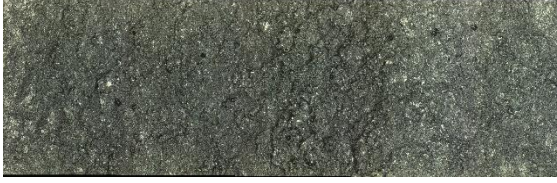
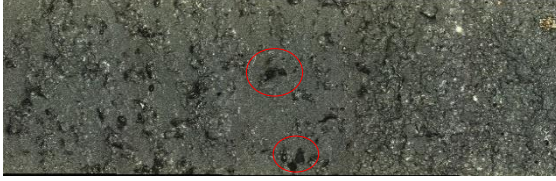
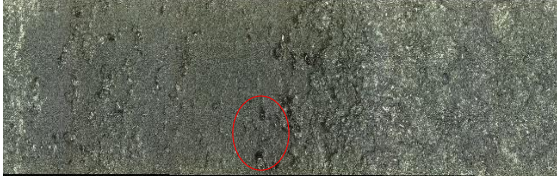
Fig. 6. Images of the SLS nylon driving and driven gears at different running cycles: (a) 0 cycles, (b) 57.1×10^3 cycles, (c) 118×10^3 cycles, (d) 144×10^3 cycles, (e) 183×10^3 cycles. Examples of pits on the tooth surfaces are highlighted in red.

The surfaces of SLS printed nylon gear teeth were initially significantly rougher ($S_a = 20.85 \mu\text{m}$) than those of the injection-moulded gears. Figure 6(a) shows an image of the gear surface of the SLS printed pinion (driving gear), revealing its rough surface

finish resulting from the manufacturing process. The surface became relatively smoother during the wear process (Figure 6(b)-(c)). At 183×10^3 cycles (Figure 6(d)), there was a significant number of large pits

some pits formed into larger ones before 57.1×10^3 cycles. And then, the number of pits as slightly decreasing until 144×10^3 cycles. At 183×10^3 cycles, the surface became smoother ($S_a = 11.91 \mu\text{m}$) although few more larger pits were observed.

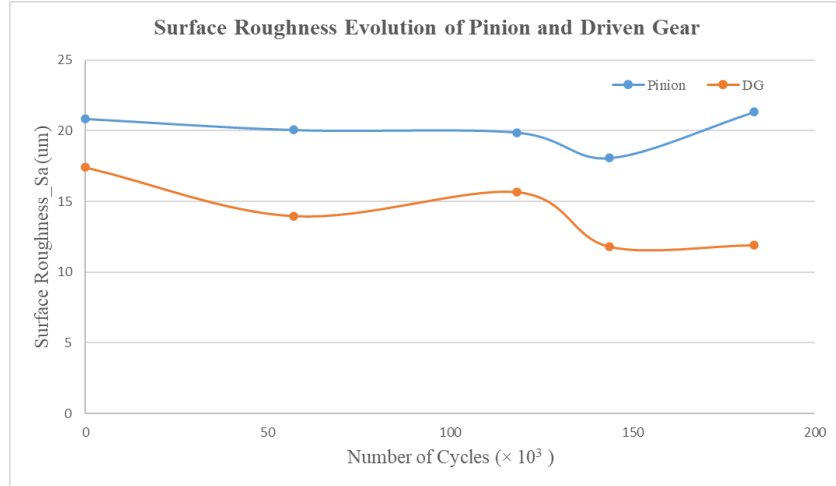
Fig. 7. The surface roughness (S_a) values vs running cycles of the driving (pinion) and driven gear (DG) made using the SLS printing method.

The pinion consistently had a higher surface roughness than the driven gear. The S_a values of the contact surfaces of both the driving and driven gears were measured and are presented in Figure 7.

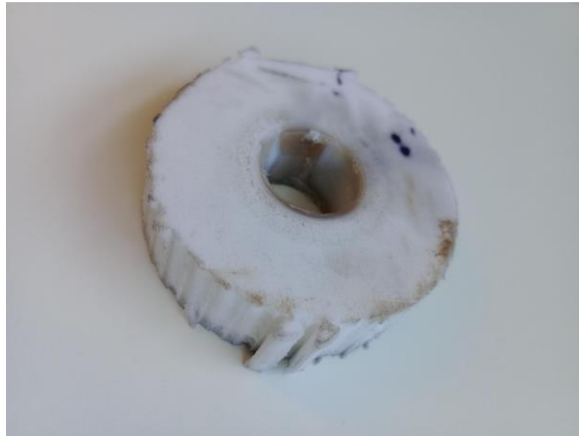
Fig. 8. Failed driving gear made of nylon using the SLS method.

a 20 Nm load was applied. Soon after the increase to 20 Nm, most of the gear teeth broke off at the root, as shown in Figure 8.

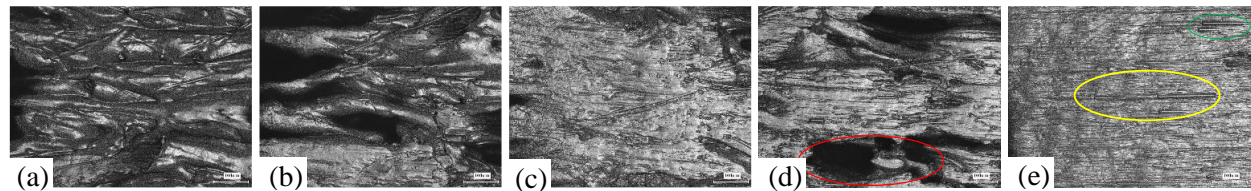
Fig. 9. Images of the driving gear of the FDM nylon gears at different running cycles: (a) 0 cycles, (b) 32.1×10^3 cycles, (c) 76.6×10^3 cycles, (d) 94.1×10^3 cycles, (e) 110×10^3 cycles. Examples of scratch marks caused by the sliding motion are highlighted in yellow, while pits on the tooth surface are highlighted in red. The size of each image is about $600 \mu m$ by $500 \mu m$.

In comparison to the injection-moulded nylon gears, the initial surface roughness of the FDM nylon gears was high. Figure 9 shows that the driving gear underwent varying degrees of polishing throughout the test. Specifically, the driving gear experienced a rapid polishing phase before 76.6×10^3 cycles (Figure 9(c)), followed by a rapid growth phase of large pits between 76.6×10^3 and 94.1×10^3 cycles (highlighted in red in Figure 9(d)). During these two stages, pitting gradually formed and condensed into larger pits by 94.1×10^3 cycles. The largest pit reached approximately $300 \mu\text{m}$. Additionally, the contact pressure at these surface irregularities increased with

increasing applied torque (from 8 Nm to 10 Nm), which resulted in abrasive wear between the meshing surfaces. By 110×10^3 cycles (Figure 9(e)), the pits on the tooth surface had almost disappeared and resulted in a very smooth surface, which left primarily

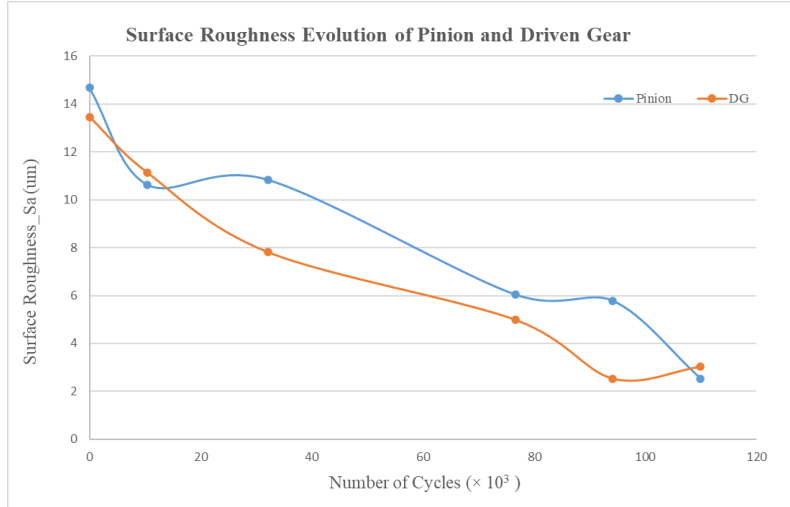
Fig. 10. The surface roughness (Sa) values vs running cycles of the driving (pinion) and driven gear (DG) made using the FDM printing method.

20 Nm. The decreasing trend of the S_a values shown in Figure 10 also confirms the surface

For the driven gear, the polishing process occurred from the beginning of the test until 94.1×10^3 cycles, as shown in Figure 10. Surface pitting was observed during this process, and most of pits were less than $100 \mu m$ in size. At 94.1×10^3 cycles, the surface roughness ($S_a = 5.75 \mu m$) of the pinion was higher than that of the driven gear, which is $2.53 \mu m$. Due to the difference in the surface roughness values of the two contact surfaces, it is reasonable to see that the surface of the pinion experienced a further smoothing process, while the surface of the driven gear became rougher at the end of the test.

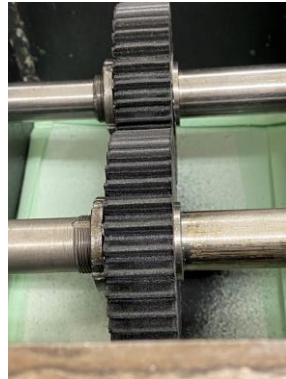
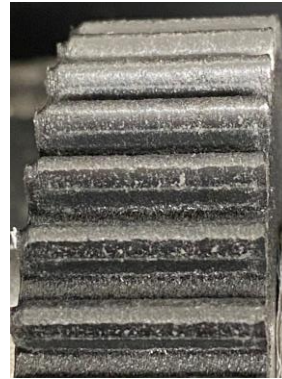
Fig. 11. (a) A large number of wear particles generated during the FDM nylon gear test, (b) the worn gear surface at the end of the test.

Figure 11 shows wear particles and the gear surface at the end of the test.

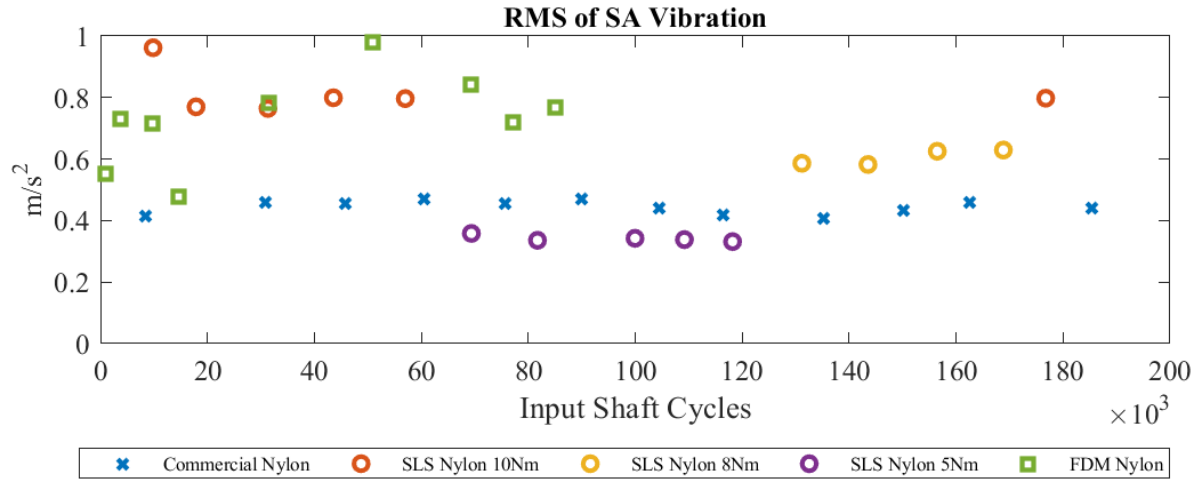
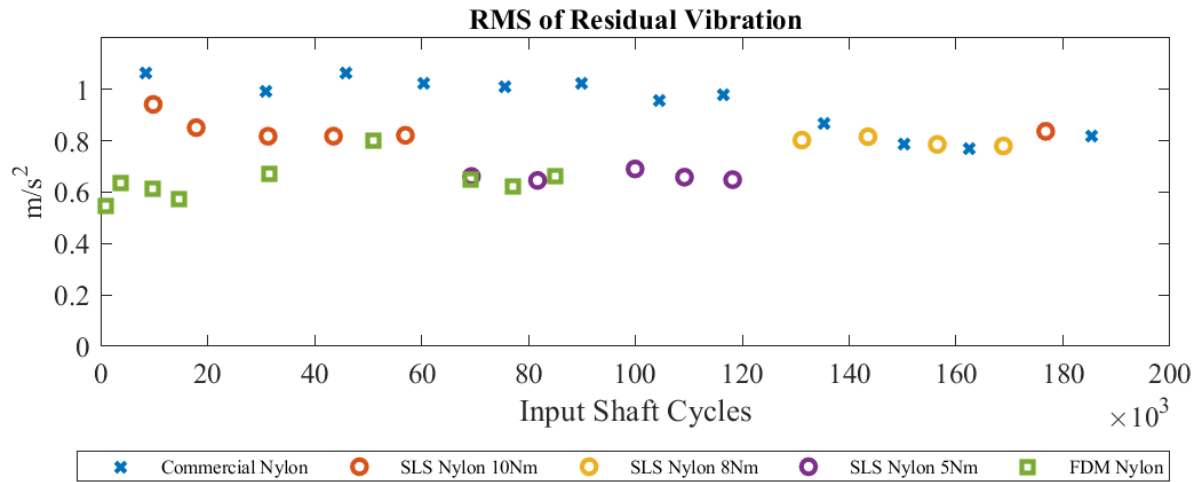
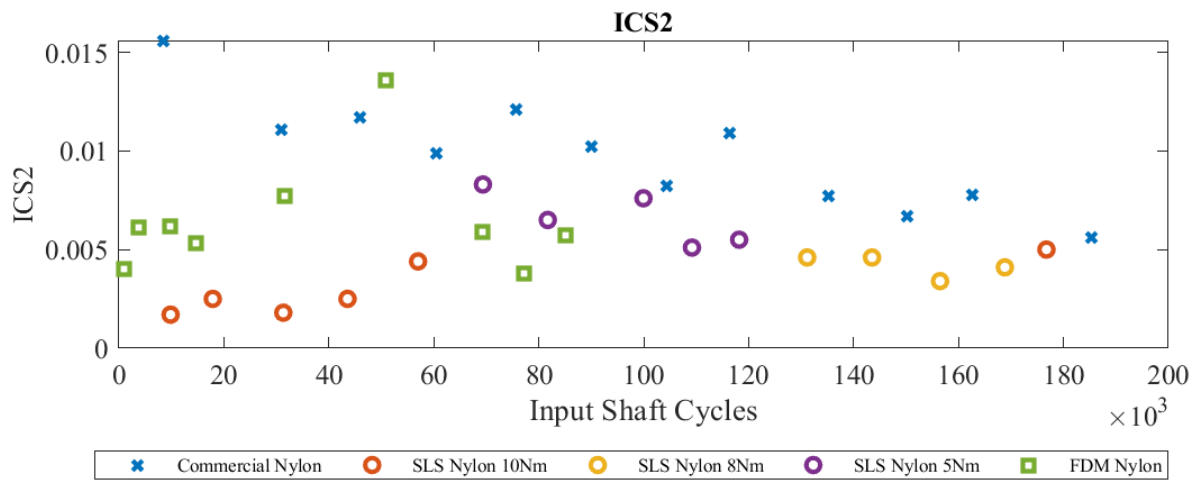
Fig. 12. Vibration signal comparison and trends: (a) RMS of SA with respect to input shaft, (b) RMS of residual signal, and (c) ICS2 for three different nylon gears.

The comparison of the RMS vibration and ICS2 results for commercial nylon, SLS nylon, and FDM nylon can be seen in Figure 12. The vibration results for commercial nylon were taken at 10 Hz and 10 Nm, while the FDM nylon result was taken at 10 Hz and 5 Nm. Those measurements were chosen because they were taken in the early stages

The RMS of the input shaft SA signal is shown in Fig.12(a). At the same operating conditions (10 Hz and 10 Nm), SLS nylon's result is higher than the commercial nylon result. Meanwhile, even though FDM nylon was run at a lower load (5 Nm), the RMS of the SA signals was higher than that of the commercial gears and similar to that of the SLS nylon gears. The decrease in the value of the SLS nylon RMS around 60×10^3 cycles was caused by the reduction in load to 5 Nm. However, it increases just after 120×10^3 cycles when the load increases to 8 Nm. Commercial nylon has the most stable RMS value of the three gears, with SLS nylon close behind, and a greater fluctuation in the FDM nylon gears. However, it is interesting to note that the result for all gears is quite stable (within ~2:1, or 6 dB, variation) and there is no discernible trend with wear progression.

As for the residual signal results (Fig.12(b)), which present only the random components, the FDM nylon becomes more stable. The results from the SLS and commercial gears are also quite stable (allowing for the different loads in the SLS gears), but with a slightly decreasing trend for the commercial gears.

The ICS2 results can be seen in Fig.12(c). It is shown that the result from the commercial

gears shows a marked downward trend with wear, while the FDM nylon's results are quite flat, albeit with some noise. Meanwhile, the SLS nylon gears display an increase throughout the 10 Nm measurements. The increasing value in the middle of the cycles is probably due to the influence of load change, noting that the ICS2 metric is normalised by signal power, so a reduction in RMS associated with lower load may lead to a higher level of cyclostationarity. Of the three vibration metrics, ICS2 displays the greatest sensitivity to wear progression, yet with different trends for the three gears.

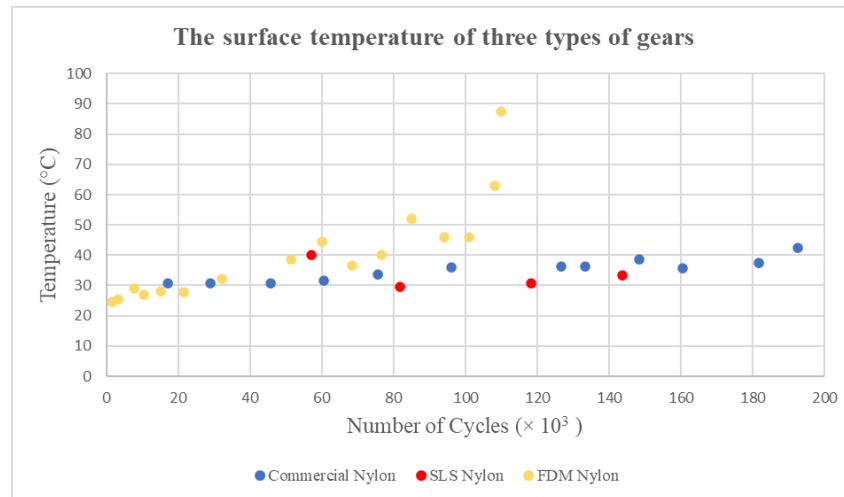
Fig. 13. The surface temperature of teeth in contact for three types of nylon gears.

The surface temperature changes of commercial nylon, SLS nylon, and FDM nylon gears are shown in Figure 13.

It can be seen that the surface temperature of commercial nylon gears remained at a low level. It gradually increased from 30.8°C at the first measurement to 42.5°C at the end of the test. No obvious thermal failure was observed even though a high torque of 20 Nm was applied on the gears for 10 minutes at the end of the test, which demonstrates the

The surface temperature of FDM gears grew more rapidly than that of the commercial gears, rising from 24.7°C to 87.6°C. At the end of the test, when a torque of 20 Nm was applied for 2 minutes, the gear temperature increased most rapidly. Slight deformation and surface melting were observed on the teeth. Thermal deformation is the main cause of the failure.

On the other hand, the surface temperature of SLS gears showed a decreasing trend in the period that the applied torque was between 0 and 10 Nm. However, most of the teeth fractured at the root, indicating that the gears failed due to the teeth shearing at 20 Nm. The surface temperature could not be measured since most of teeth already fractured at the end, but it is believed that material softening was not the main cause of the failure as no obvious plastic deformation such as melting was observed at the fractured surface under the laser scanning microscope.
